**BOARD OF TRUSTEES  
Regular Meeting  
October 10, 2018  
7:00 p.m.**

# Charter Township of Union Pump Station #7 Sanitary Sewer Service Area Study

September 2018

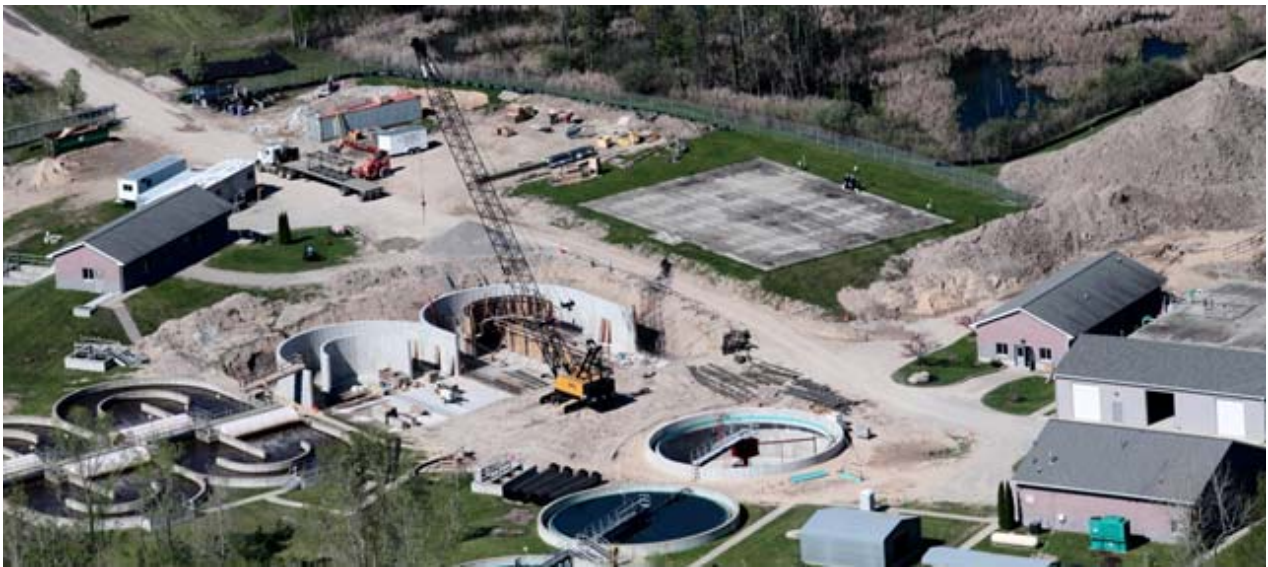
*The wastewater treatment plant under construction (2015), a planned upgrade to increase the capacity from 1.2 to 2.4 MDG.*

Wastewater treatment for Union Township takes place at the wastewater treatment plant (WWTP). This facility consists of a 2.4 million gallon per day (MGD) oxidation ditch treatment system with additional phosphorous removal, filtering and disinfection which discharges treated effluent to the Chippewa River. Secondary treatment includes aerobic digestion, thickening and onsite storage of solids.

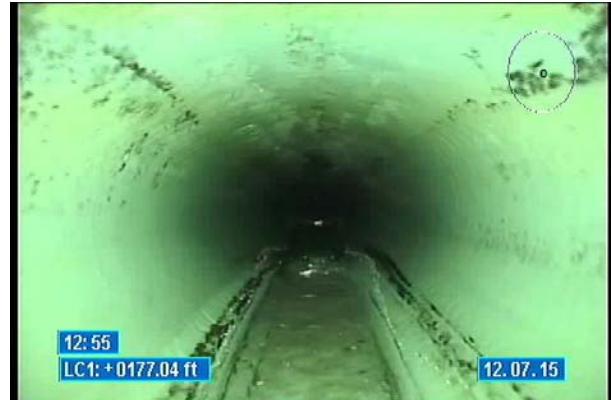
*Sample shot from televised inspection – within gravity sewer between MH#227B & MH#227A on River Road*

Their techniques recorded defects throughout the pipes/ manholes and applied the information to develop an overall condition rating. Pipes and manholes with poor condition ratings are likely sources of excess flows and were targeted for rehabilitation and/or replacement. Maps and reports were prepared and provided. These included tabulated results for Defects by Inspection, Grade Count, and Overall Rating. The survey completed in 2014 included segments within the Pump Station #7 and #8 service areas. GFA reviewed the documents and we’ve included a synopsis on the following pages. Copies of the original reports are included in the Appendix.

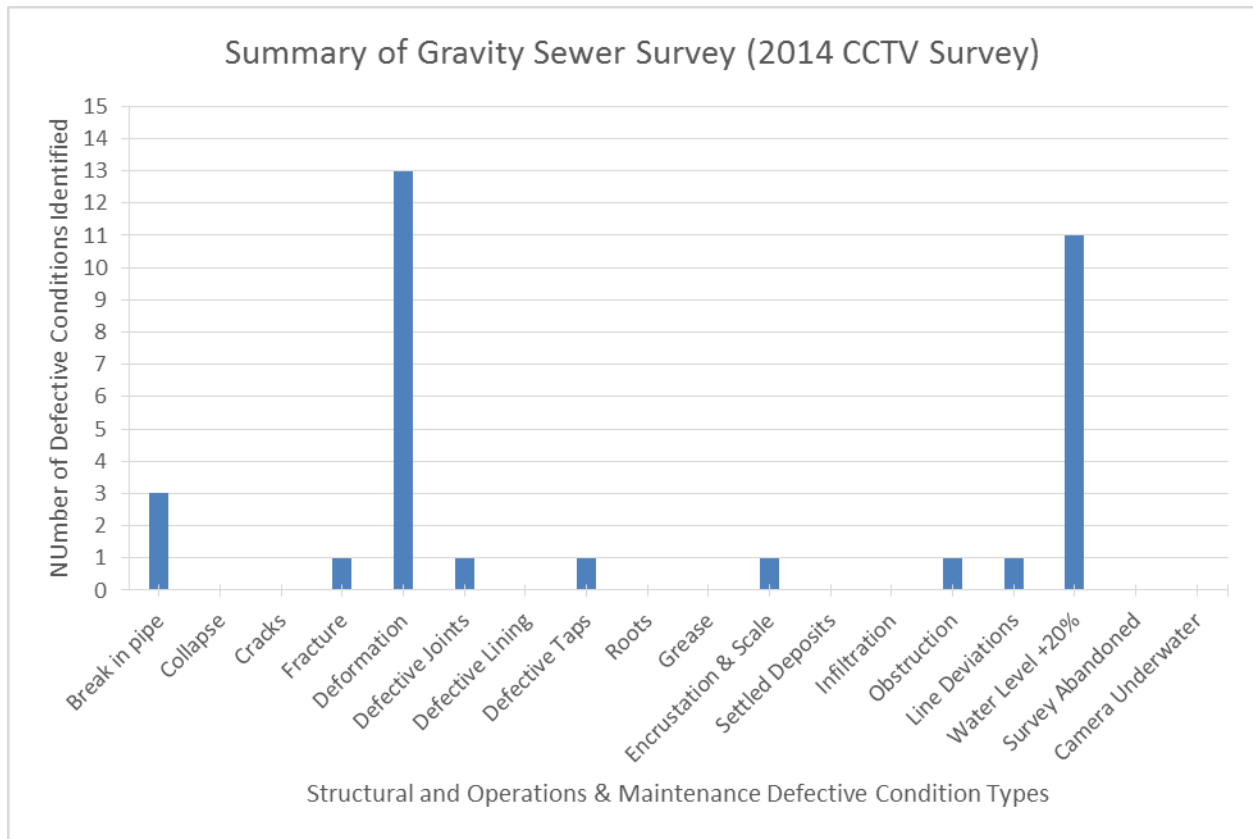
**Graph 3-1- Defects by Inspection Summary, PS #7 & #8 Service Area**

GFA completed a detailed review of the reports and maps that were completed by Plummer’s in 2014 relevant to the Pump Station #7 service area. The following figures and tables provide a synopsis of the data as it pertains to the condition assessment related to structural and O&M defects. The detailed reports and maps are included in the Appendix.

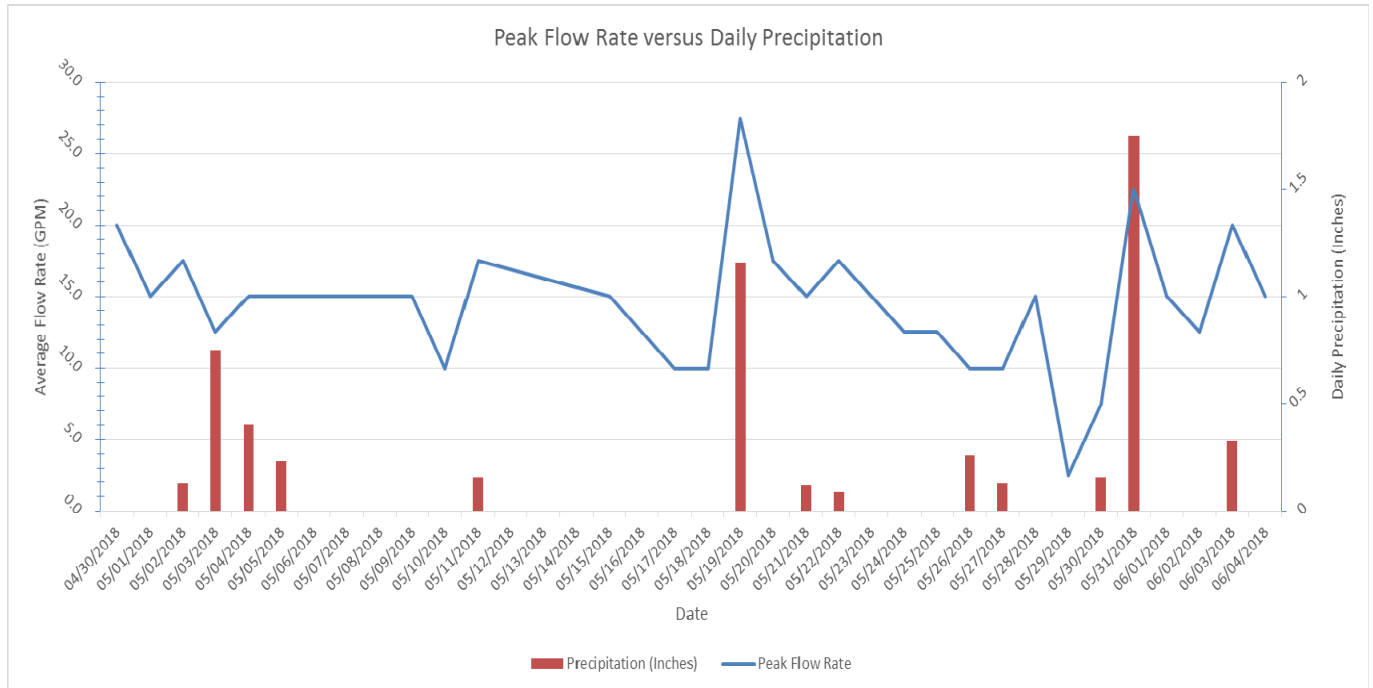
**Graph 5-2: MH #208 (Lincoln Road), Peak Hour Flow Rate vs. Daily Precipitation (April 30-June 3, 2018)**

As a means of comparison and determine the extent of I/I that was occurring in the system, further extrapolation of the flow monitoring data was completed to compare the peak hour flow that was recorded during a dry weather condition versus a wet weather (rain event) condition. As presented from the table below, there was some impact (30% increase) in flow monitored in the system during a rain event. The infrastructure operated as designed and had reserve capacity when handling the additional load without incident nor impacts to users.
